# **Annual Inspection**

Barby & Onley Parish Council

Barby Play Area

Inspected: 28-June-2022 - 12:00 by Jim Hayes

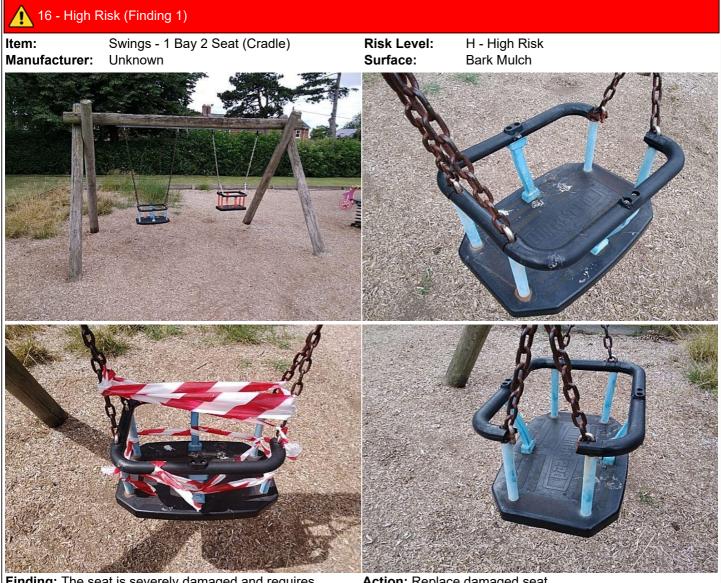
Finding: The seat is severely damaged and requires replacing

Action: Replace damaged seat

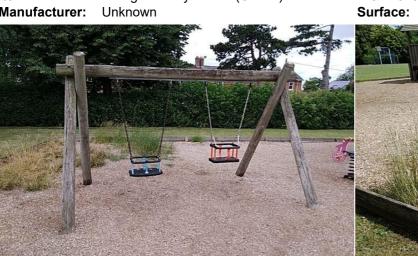
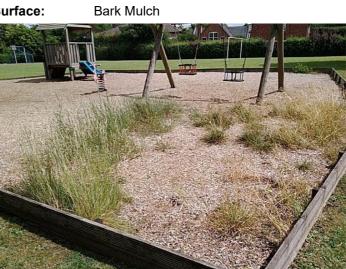
Finding: There are weeds/vegetation growth between or around the edges of the surfacing

Action: Remove weeds/vegetation growth

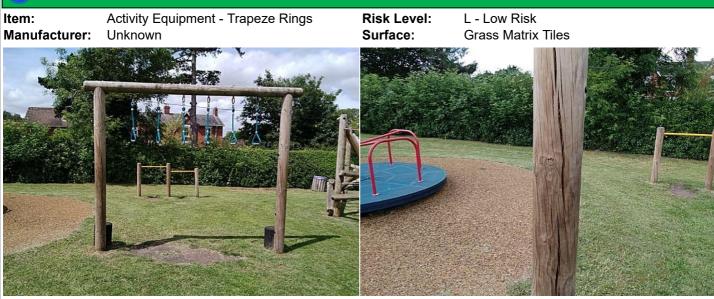
Finding: The timber has a number of splits/shakes or air Action: Monitor to ensure the splits do not cross through cracks and this may affect the stability or allow water ingress fixing points of the structure and/or cause any instability which will accelerate the rotting process

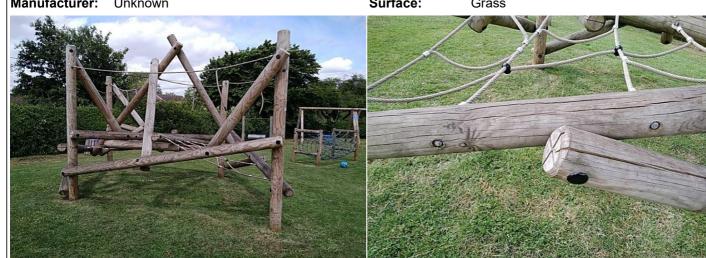
Finding: There is/are bolt cap covers missing or damaged Action: Replace missing or damaged bolt cap covers on the item

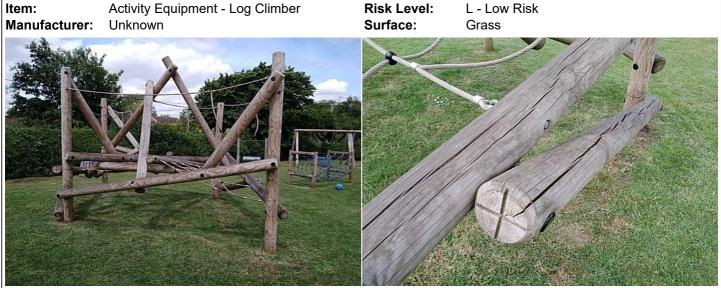
Finding: The timber has a number of splits/shakes or air Action: Monitor to ensure the splits do not cross through cracks and this may affect the stability or allow water ingress fixing points of the structure and/or cause any instability which will accelerate the rotting process

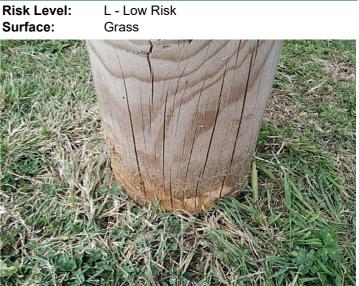
**Finding:** There is some strimmer / machinery damage apparent on the posts, this can penetrate the preservative applied to the timber and accelerate the rotting process

Action: Monitor for any deterioration (rot) and replace as required

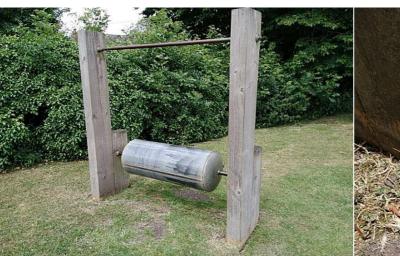
Finding: There is some strimmer / machinery damage apparent on the posts, this can penetrate the preservative applied to the timber and accelerate the rotting process

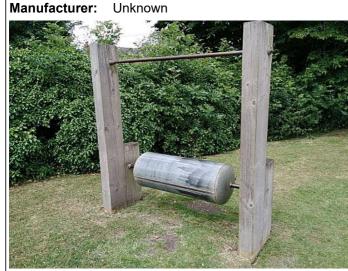
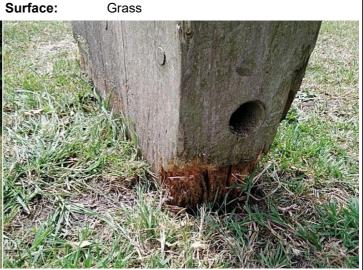
Finding: There is some evidence of rot in the timber

Action: Monitor for any further deterioration and replace as required

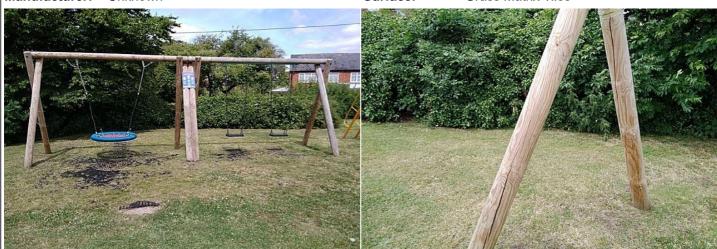
**Finding:** The timber has a number of splits/shakes or air **Action:** Monitor to ensure the splits do not cross through cracks and this may affect the stability or allow water ingress fixing points of the structure and/or cause any instability which will accelerate the rotting process

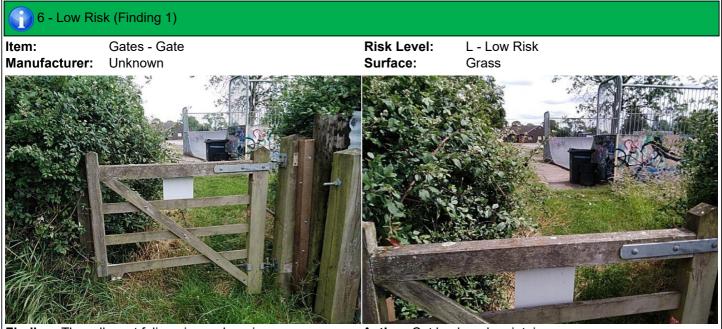
Finding: The adjacent foliage is overhanging

Action: Cut back and maintain

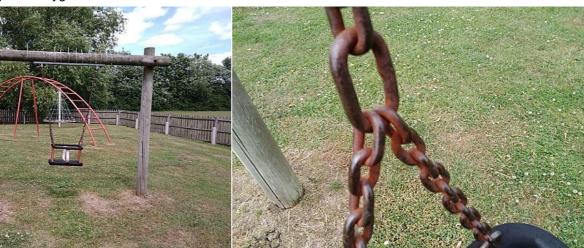
Finding: There is some notable evidence of chain wear

Action: Monitor for any further deterioration and replace when 40% worn

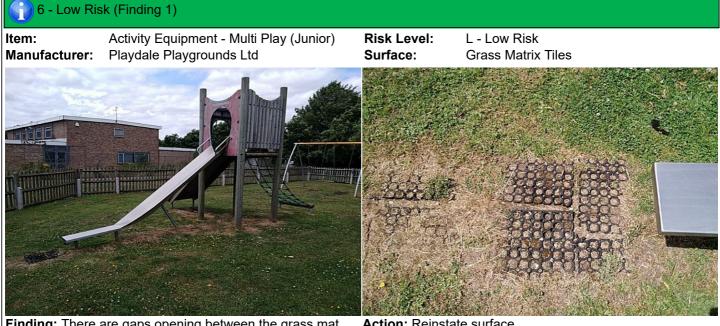
Finding: There are gaps opening between the grass mat tiles

Action: Reinstate surface

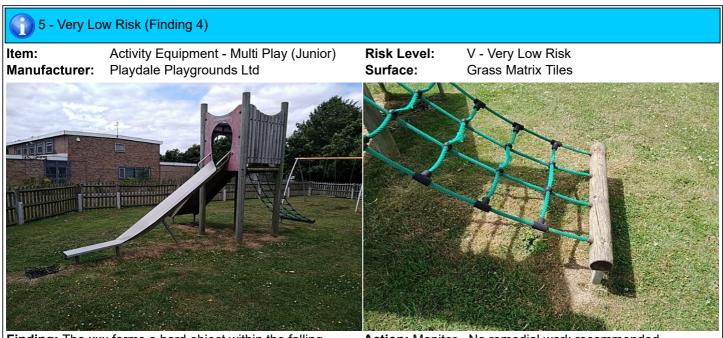
**Finding:** The xxx forms a hard object within the falling space of the equipment in contravention of the requirements of BS EN 1176 Part 1
