# **Annual Inspection**

Barby & Onley Parish Council

Barby Play Area

Inspected: 28-June-2022 - 12:00 by Jim Hayes

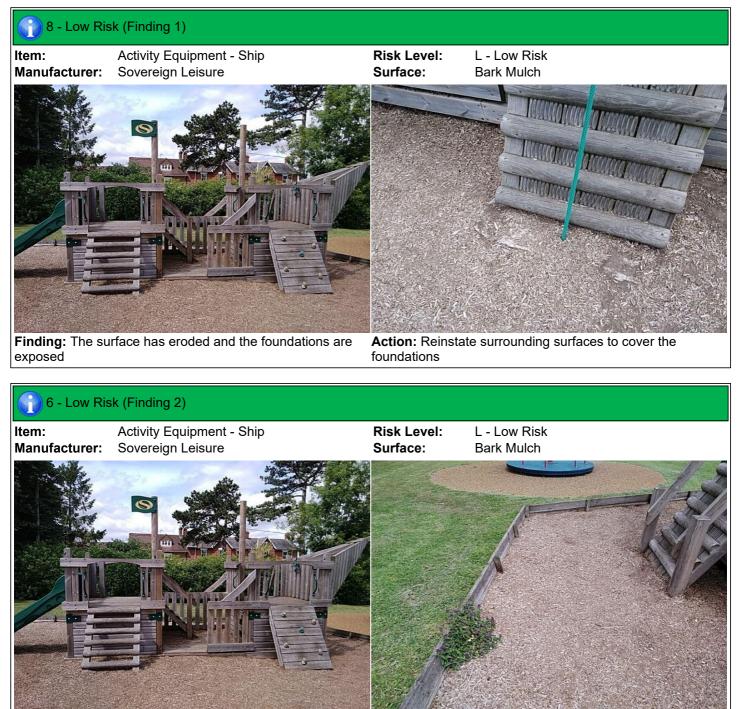
**Finding:** There are weeds/vegetation growth between or around the edges of the surfacing

Action: Remove weeds/vegetation growth

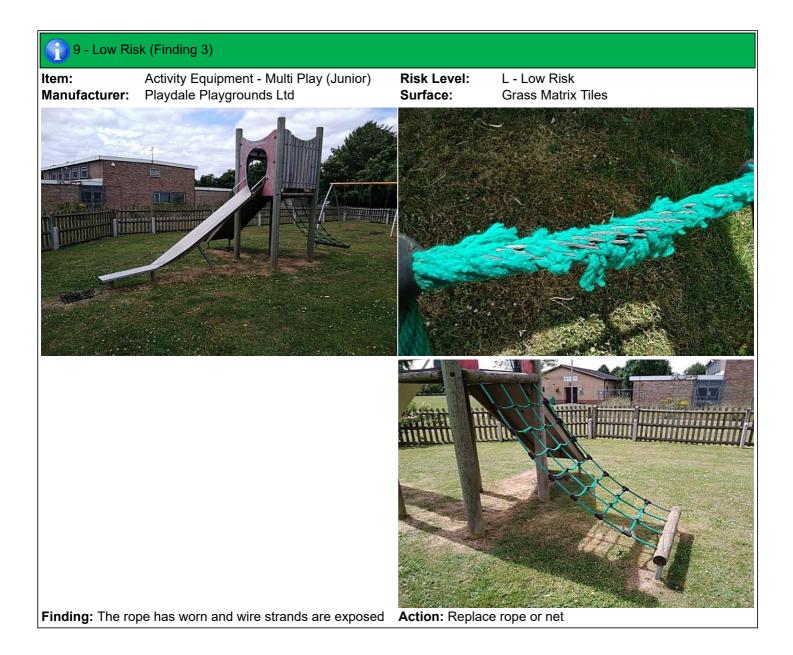
Action: Monitor - No remedial work recommended
